KA HO'OILINA MAU O LOKOEA PERPETUATING CULTURAL PRACTICES AT A PU'UONE FISHPOND: ARCHAEOLOGICAL SITE PRESERVATION PLAN LOKOEA FISHPOND KAWAILOA AHUPUA'A, WAIALUA DISTRICT, O'AHU ISLAND, HAWAI'I TMK (1) 6-2-003:002

Prepared for: Kamehameha Schools Honolulu, HI 96813

Prepared by: Christopher M. Monahan, Ph.D. TCP Hawai'i, LLC Kailua, HI 96734

December 2016

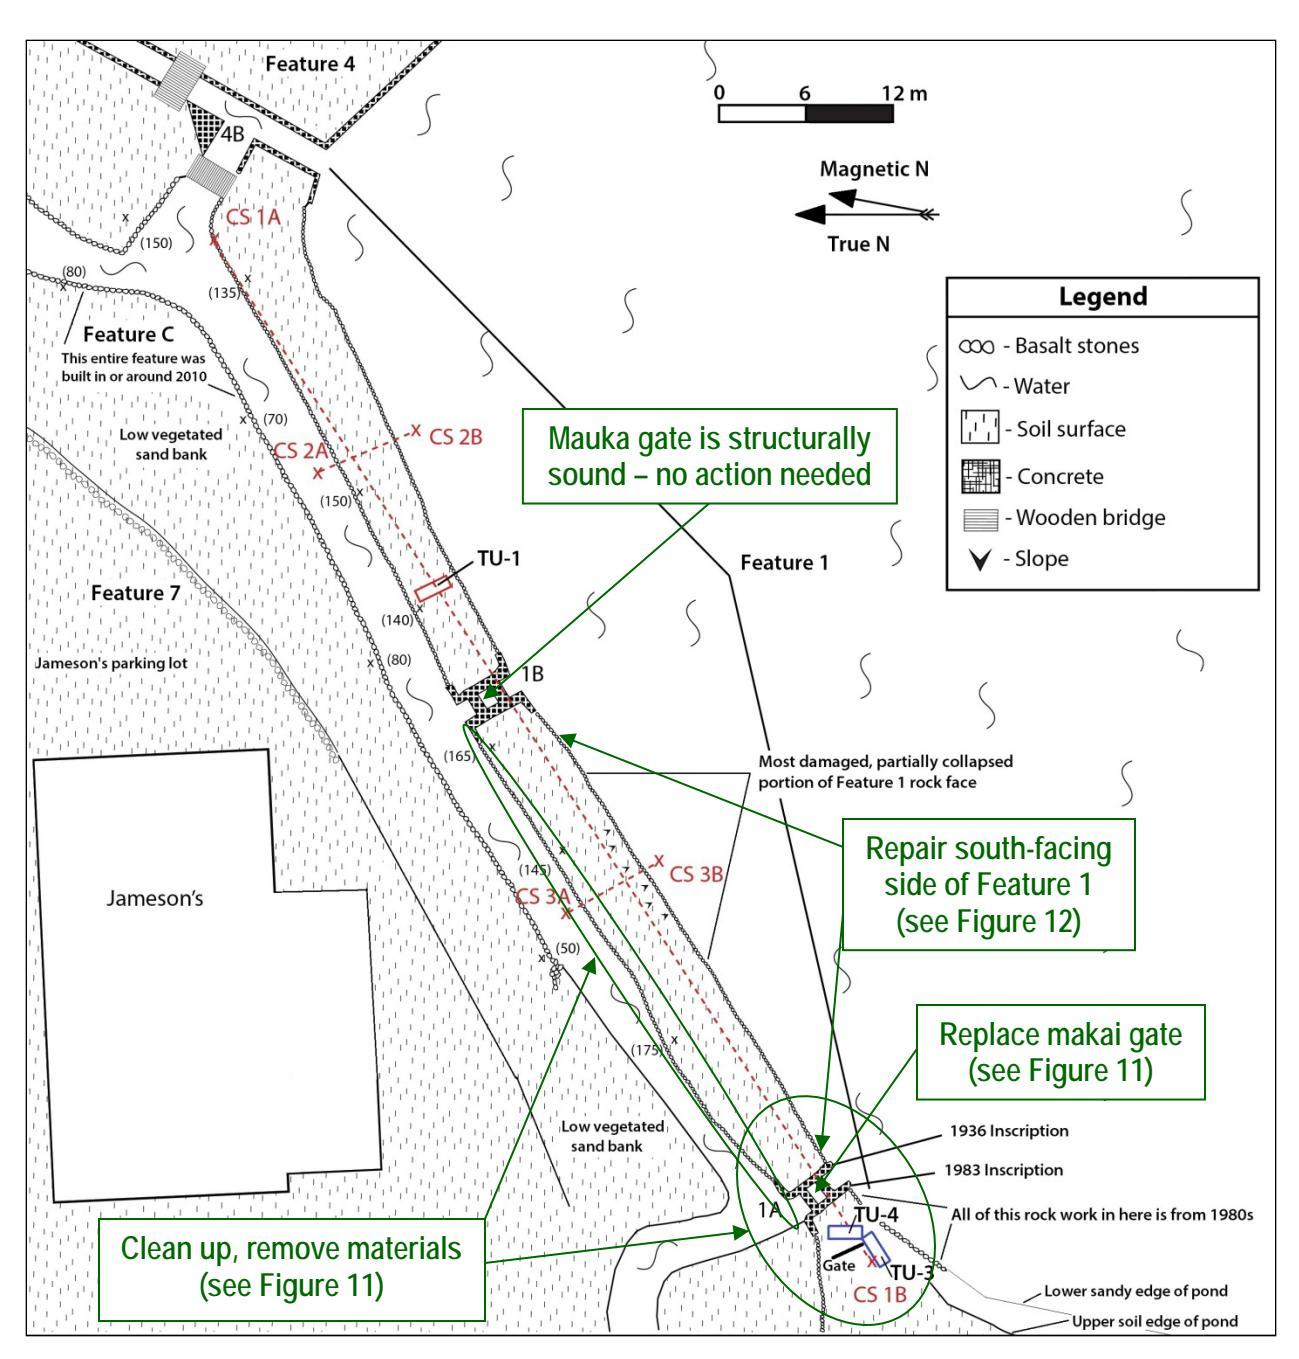
Figure 10. Feature 1 plan view with preservation actions indicated in green (see text for complete discussion); note, Jameson's is now the Haleiwa Beach House restaurant

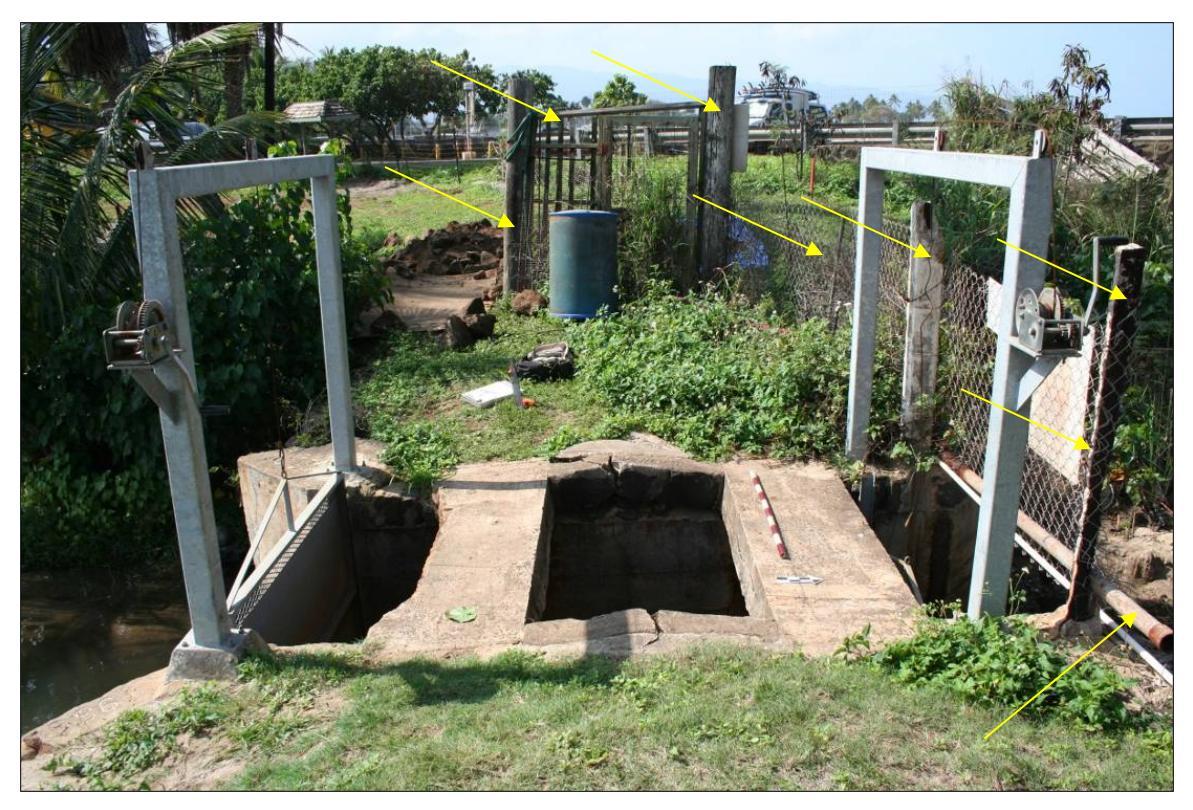
- 3. Replacement of the cast-in-place concrete and metal sluice gate at the makai end of Feature 1 is needed because this structure is cracked and failing and will soon fall into the pond. It was originally built in the 1930s, then repaired in the 1980s. It should be rebuilt using comparable materials as used in the 1930s, resulting in a consistent appearance with its companion gate in the middle of Feature 1. The most distinctive feature of this building style is an uppermost finish course of dressed basalt blocks.

Figure 11. West end of Feature 1 showing some of the materials (arrows) that should be removed in order to improve the aesthetic value of Lokoea, view west; note structural cracks in concrete gate

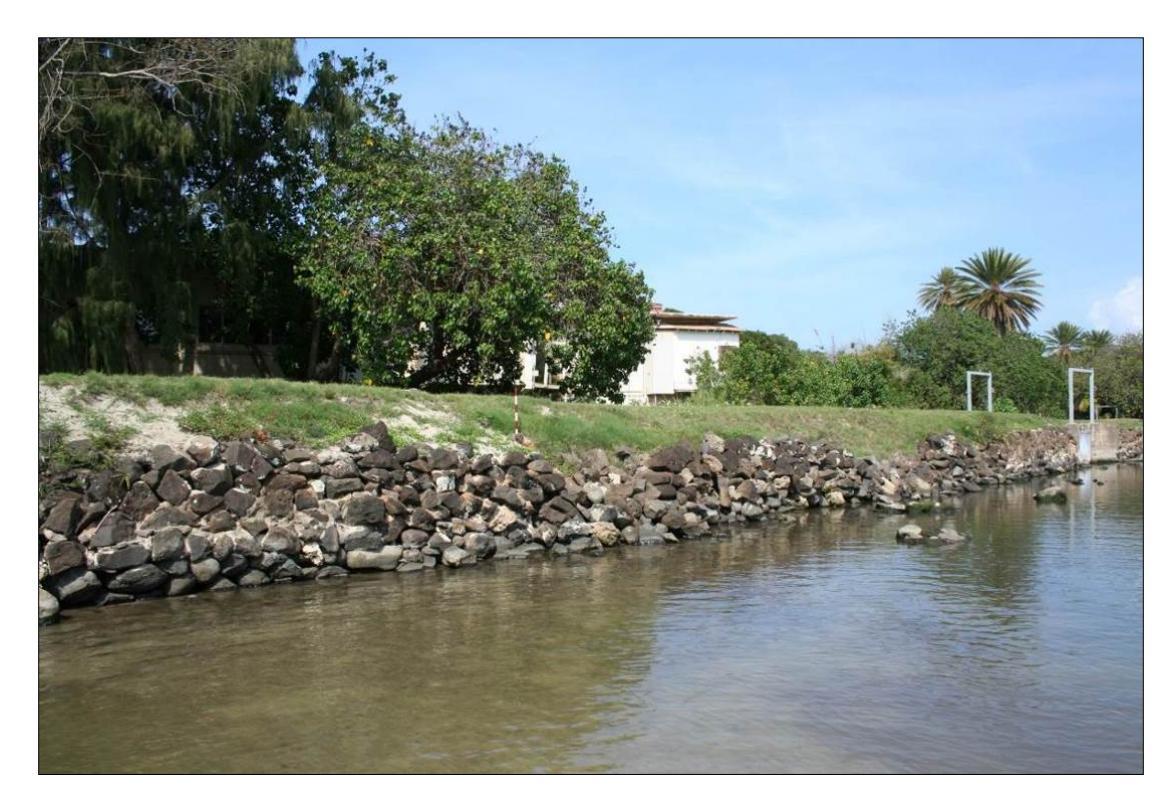
Figure 12. The main area of collapse that needs to be stabilized on Feature 1 along its south side at the west end; view northeast

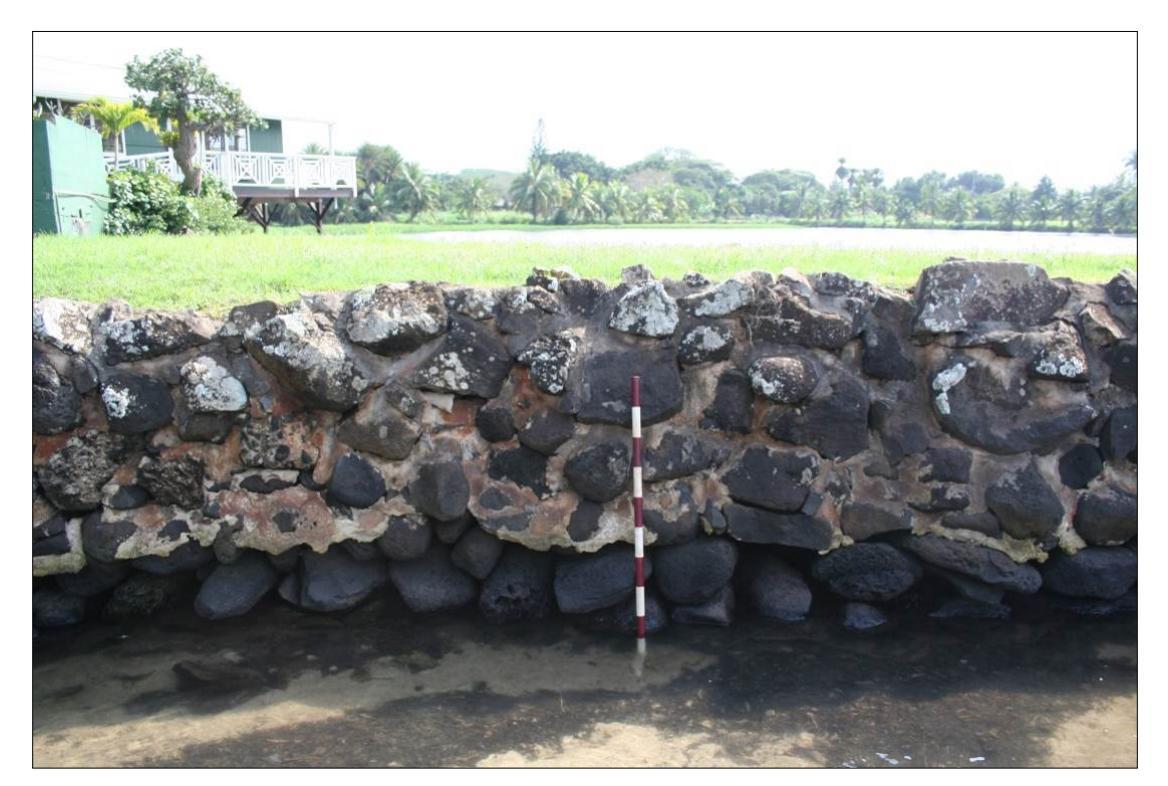
Figure 13. Representative section of Feature 1 on its north side illustrating the most recent (late 1950s) outer layer of angular rock and mortar over the original dry-stacked rounded boulders; view south

One long-term alteration that is not part of the Proposed Project, would not affect its functionality, but would improve its overall appearance, is to strip away the current (constructed circa 1957 or a bit later) outer, retaining walls of Feature 1, particularly the mortar between and around the angular and sub-angular boulders. This outer retaining wall—which is not original to Feature 1—could be replaced with dry-stacked, rounded and sub-rounded boulders, which are the original materials and construction methods (Figure 13). The AIS fieldwork demonstrated that the latter style—which is exemplified most effectively by the existing north side of Feature 2 (the smaller wall connecting the central island to the mauka [east] side of the fishpond), resembles the old appearance of Feature 1 before it was modified in the late 1950s. Given the likelihood of a significant sea-level rise, and the possibility of there being more frequent, future storms of an intense nature, it seems unwise to reduce Feature 1 back to original (lower and narrower) dimensions (as demonstrated in the AIS). Instead, repair work should focus on not disturbing the old core of the wall, but only its outer (late 1950s) surface. In this way, the wall would continue to be a formidable structure, able to withstand tidal surges, but one that more closely resembles its traditional (original) appearance.

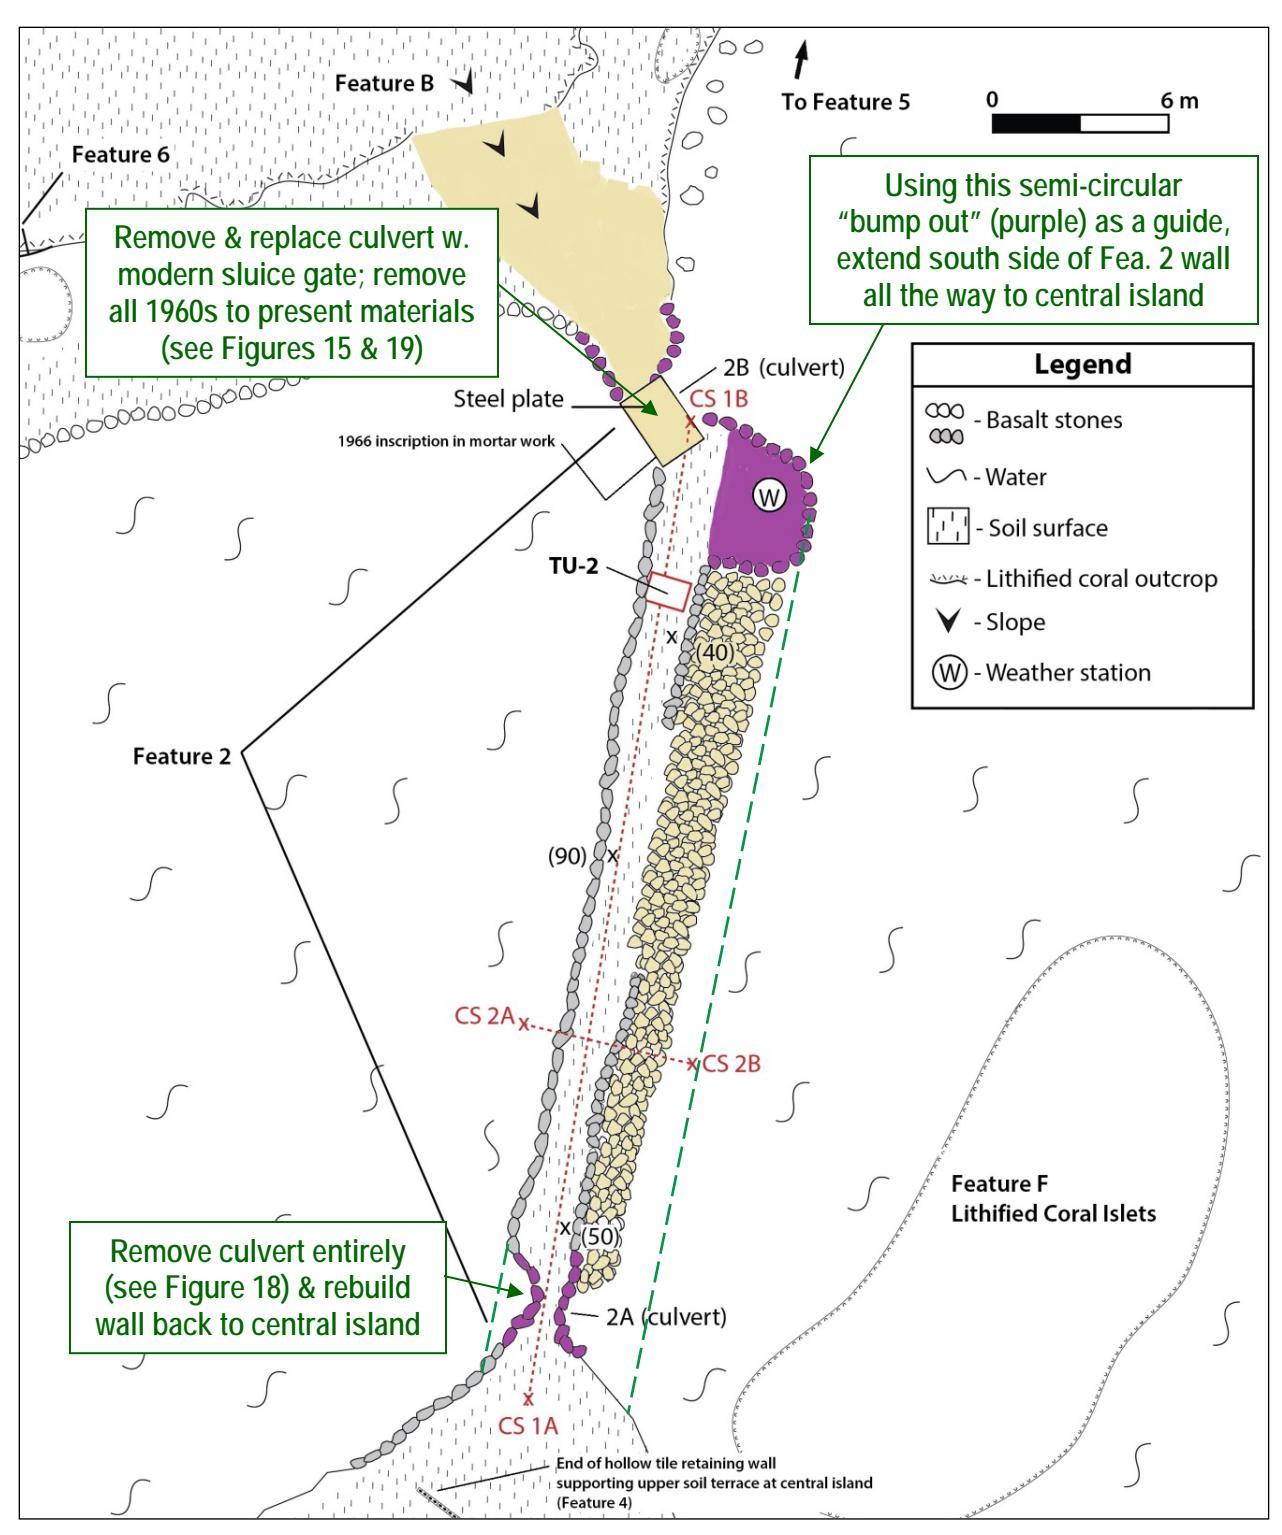
Figure 14. Feature 2 plan view with preservation actions in green; gray rock work is oldest; purple is 1960s work; yellow is circa 2010 work; green dashed lines represent lateral limits of proposed wall widening

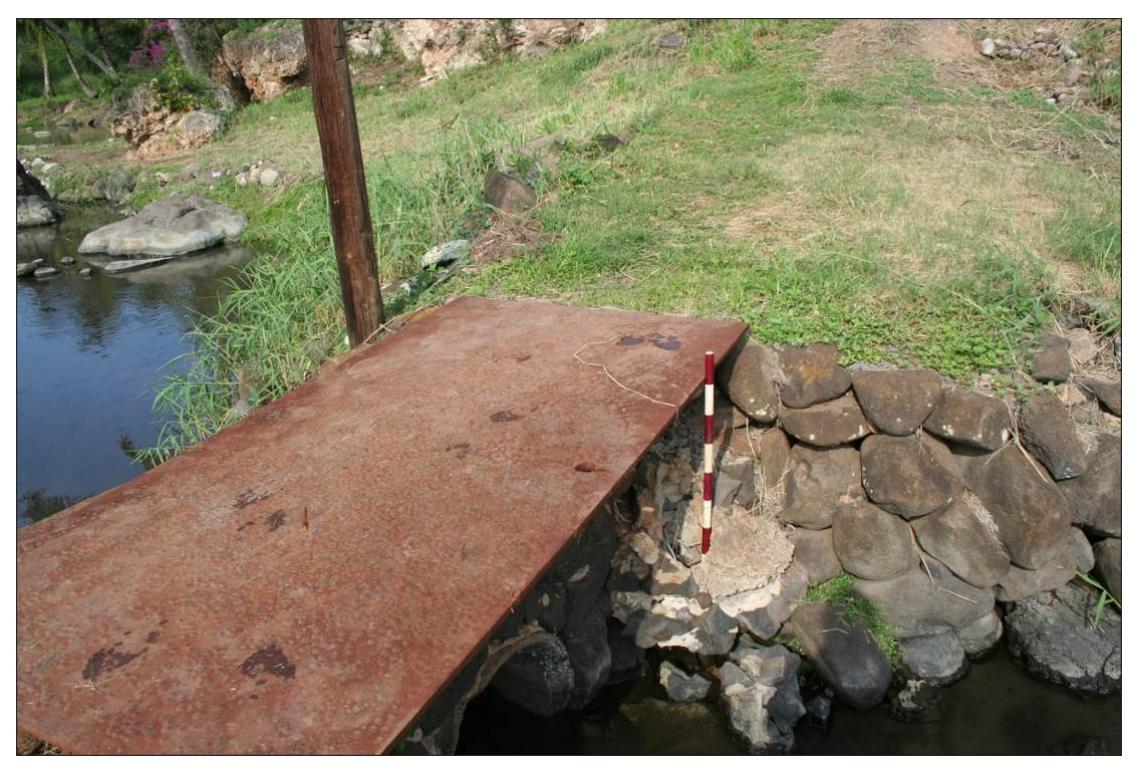
Figure 15. Mauka (east) end of Feature 2 showing culvert under steel plate, abandoned wooden post (left) and base of constructed footing for what was once a gate post (photo scale sits in old footing); view east

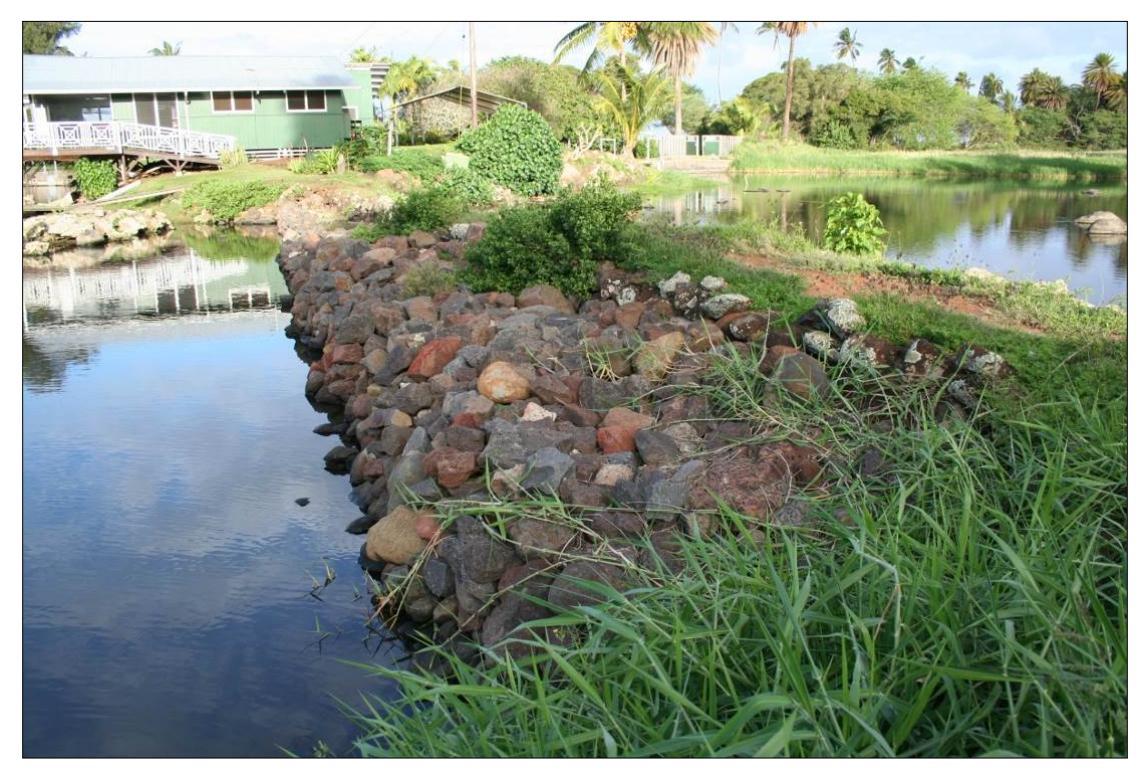
Figure 16. Detail of south side of Feature 2 showing recently-added (circa 2010) rock material; view west

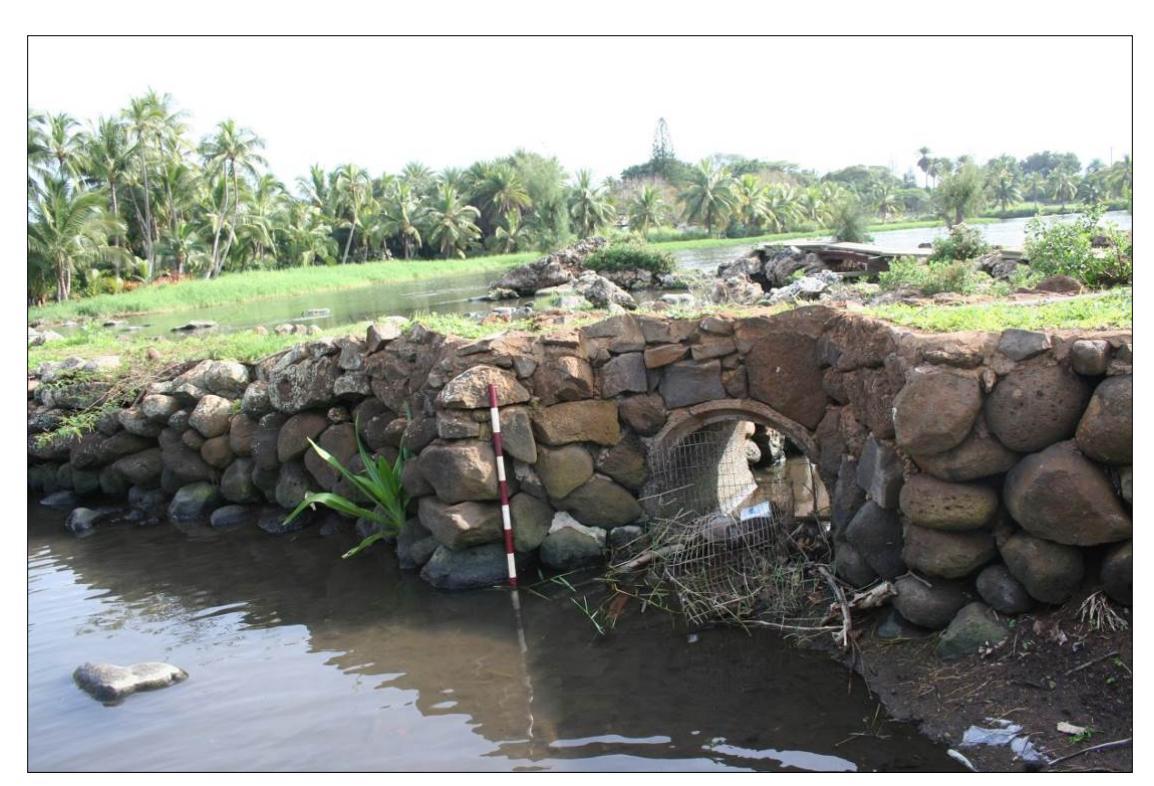
Figure 18. Makai (west) culvert that will be closed (filled in); view southwest

- 2. Close off (by filling in with pōhaku) the existing makai culvert at Feature 2, which was originally cut into the circa 1930 wall in the 1960s, is not part of its original design of this wall, and is not needed for operation of the fishpond (Figure 18). This closing off work will not use concrete or any other modern materials. Rocks and rubble will be used to fill in the existing breach in the wall. The final appearance of this wall, which will extend back to the central island, will be dry-stacked pōhaku that are visually consistent with the existing (circa 1930) Feature 2 wall.

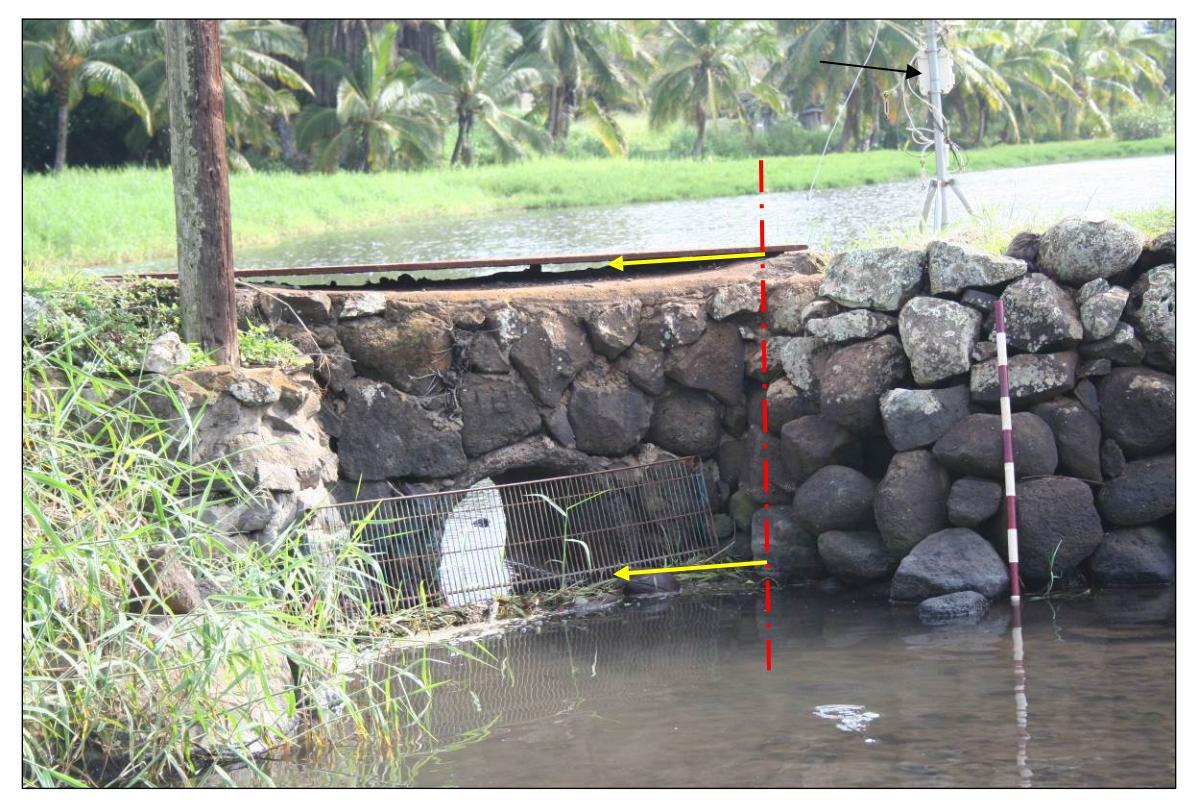
Figure 19. Mauka gate at Feature 2; everything left of dashed line will be removed; new sluice gate will be built into the dry-stacked boulder wall to the right; black arrow indicates weather station to be removed (if not already)

- 3. Replacement of the mauka culvert at Feature 2 with a sluice gate using modern materials (e.g., concrete and milled wood) is needed for operation of the fishpond (Figure 19). None of the original, circa 1930 pōhaku will be moved, removed or otherwise disturbed by this work. When complete, the final courses of this new sluice gate, including any that are visible from in or around the pond, will be dry-stacked pōhaku that are visually consistent with the existing (circa 1930) Feature 2 wall.

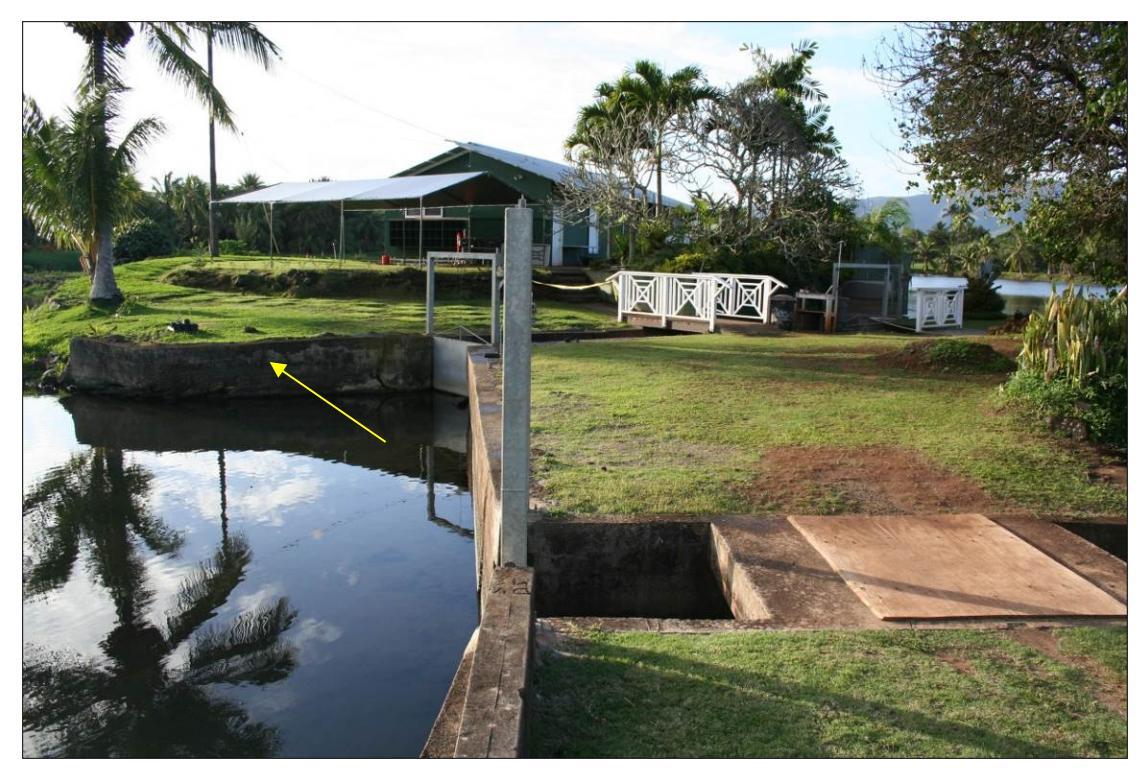
Figure 24. View of central island from main gate (entrance); structure needing stabilization indicated by yellow arrow

There is a set of dry-stacked, rock-retaining structures on the east and northeast sides of the central island. These informally-constructed features vary in terms of their physical condition from fair to poor, and their age is unknown. Their integrity has been diminished over time by the growth of a large hau thicket that until recently covered this area. When and if this rock work needs to be replaced, it would be aesthetically pleasing if it were finished in the dry-stacking style seen along the north side of Feature 2. Likewise, if repair work is ever needed of the dry-stacked, rock-retaining structure between the lower and upper terraces on the north side of the island (see Figure 25), it should be built in this Feature 2 style.

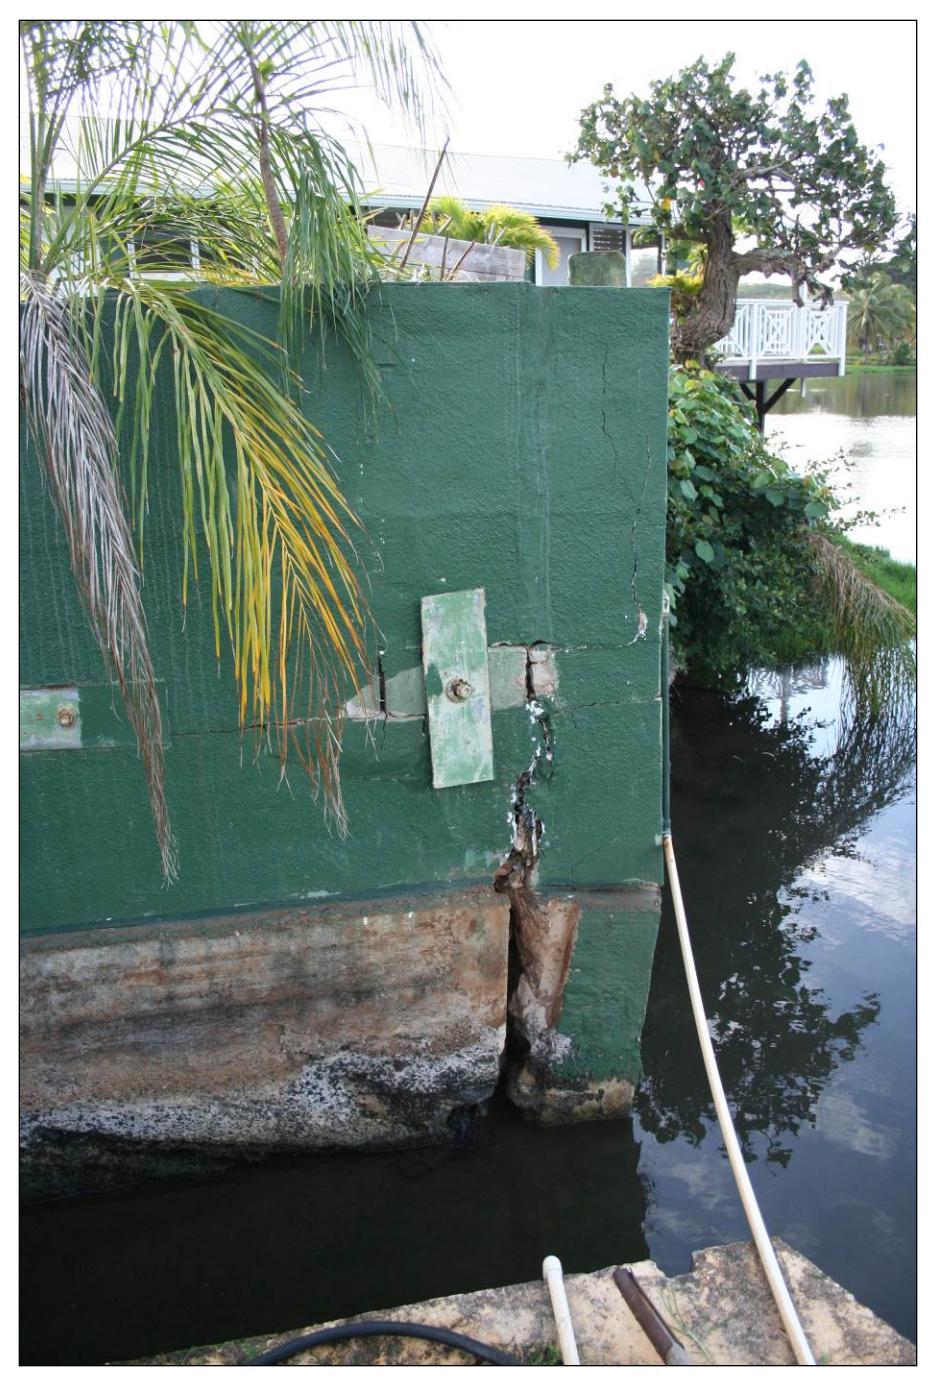
Figure 26. Damage to high concrete wall supporting the upper terrace upon which the main building is located
