KA HO'OILINA MAU O LOKOEA PERPETUATING CULTURAL PRACTICES AT A PU'UONE FISHPOND: ARCHAEOLOGICAL SITE PRESERVATION PLAN LOKOEA FISHPOND KAWAILOA AHUPUA'A, WAIALUA DISTRICT, O'AHU ISLAND, HAWAI'I TMK (1) 6-2-003:002

Prepared for: Kamehameha Schools Honolulu, HI 96813

Prepared by: Christopher M. Monahan, Ph.D. TCP Hawai'i, LLC Kailua, HI 96734

December 2016

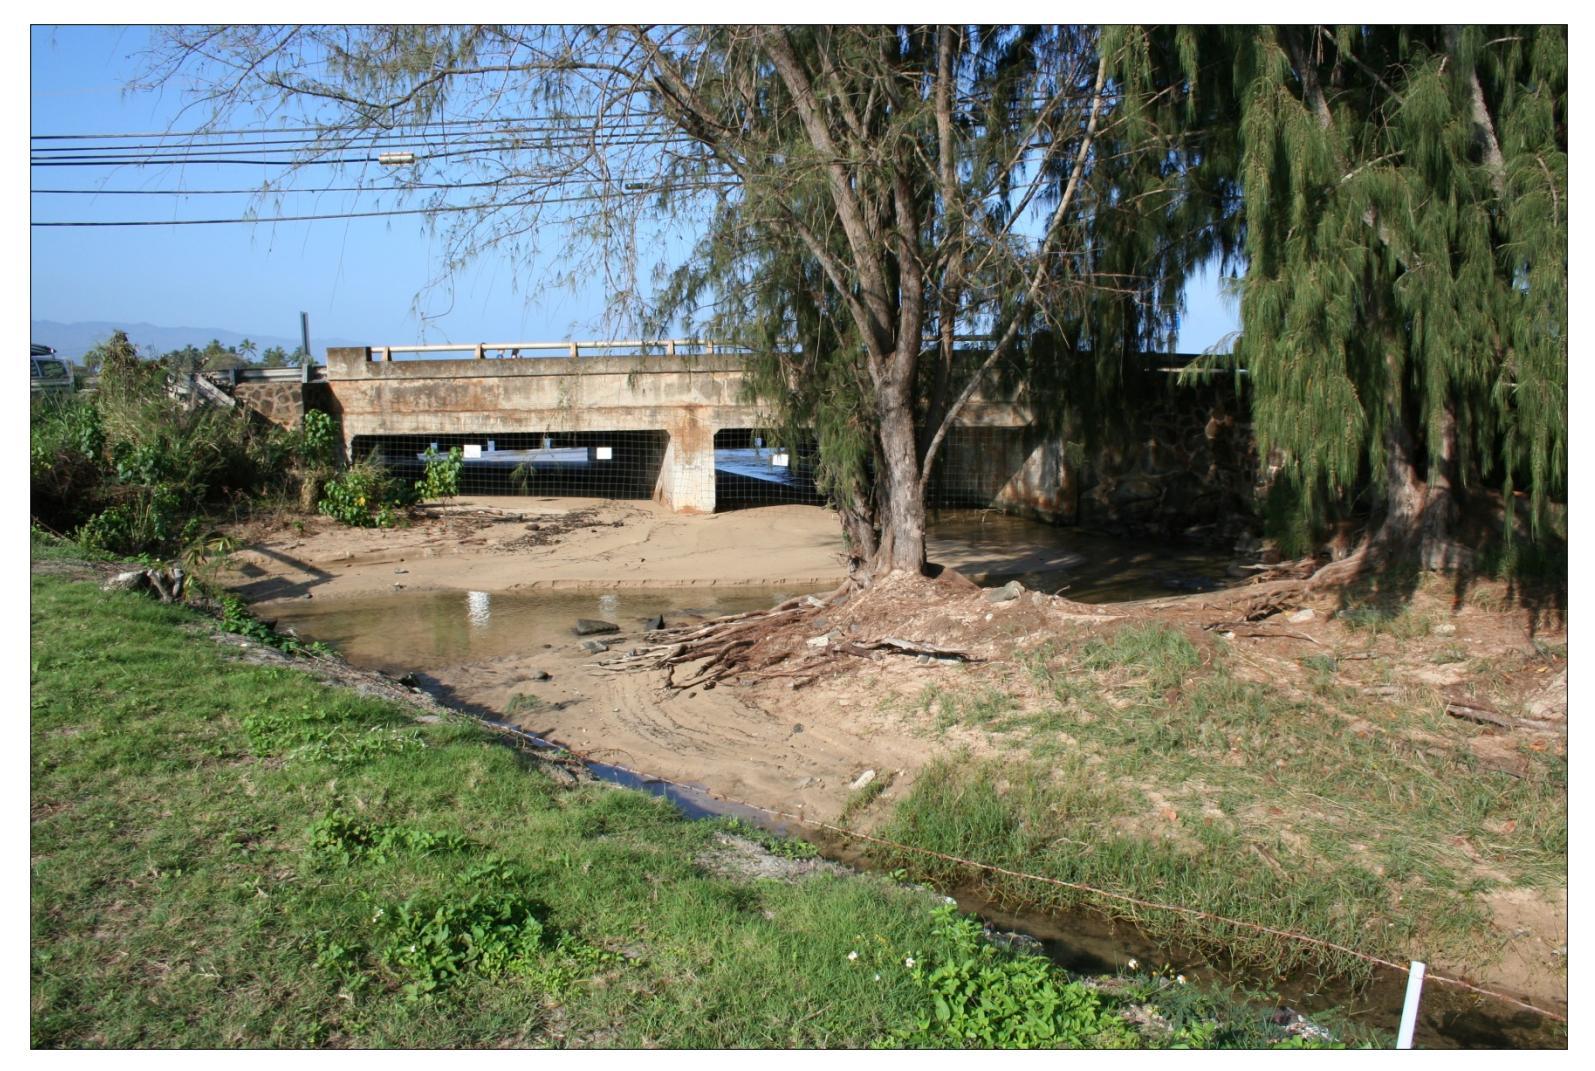
Figure 8. Lokoea Stream outlet under the bridge along Kamehameha Highway; historical accounts (Wyban 1992:8) describe children jumping from the bridge into the stream—which these days is rarely deeper than about a foot—in the middle twentieth century, indicating there used to be a few to several more feet of water in this stream system; view west

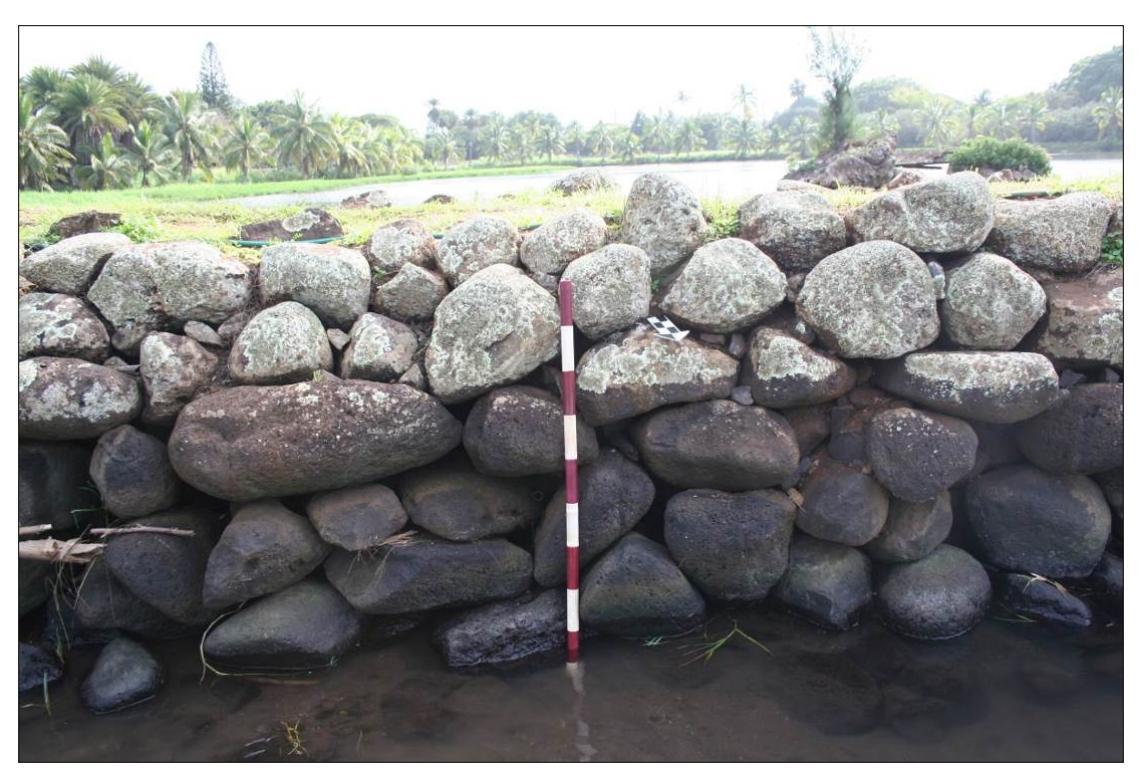
Figure 17. Representative section of north side of Feature 2 showing old-style (circa 1930s) design; view south

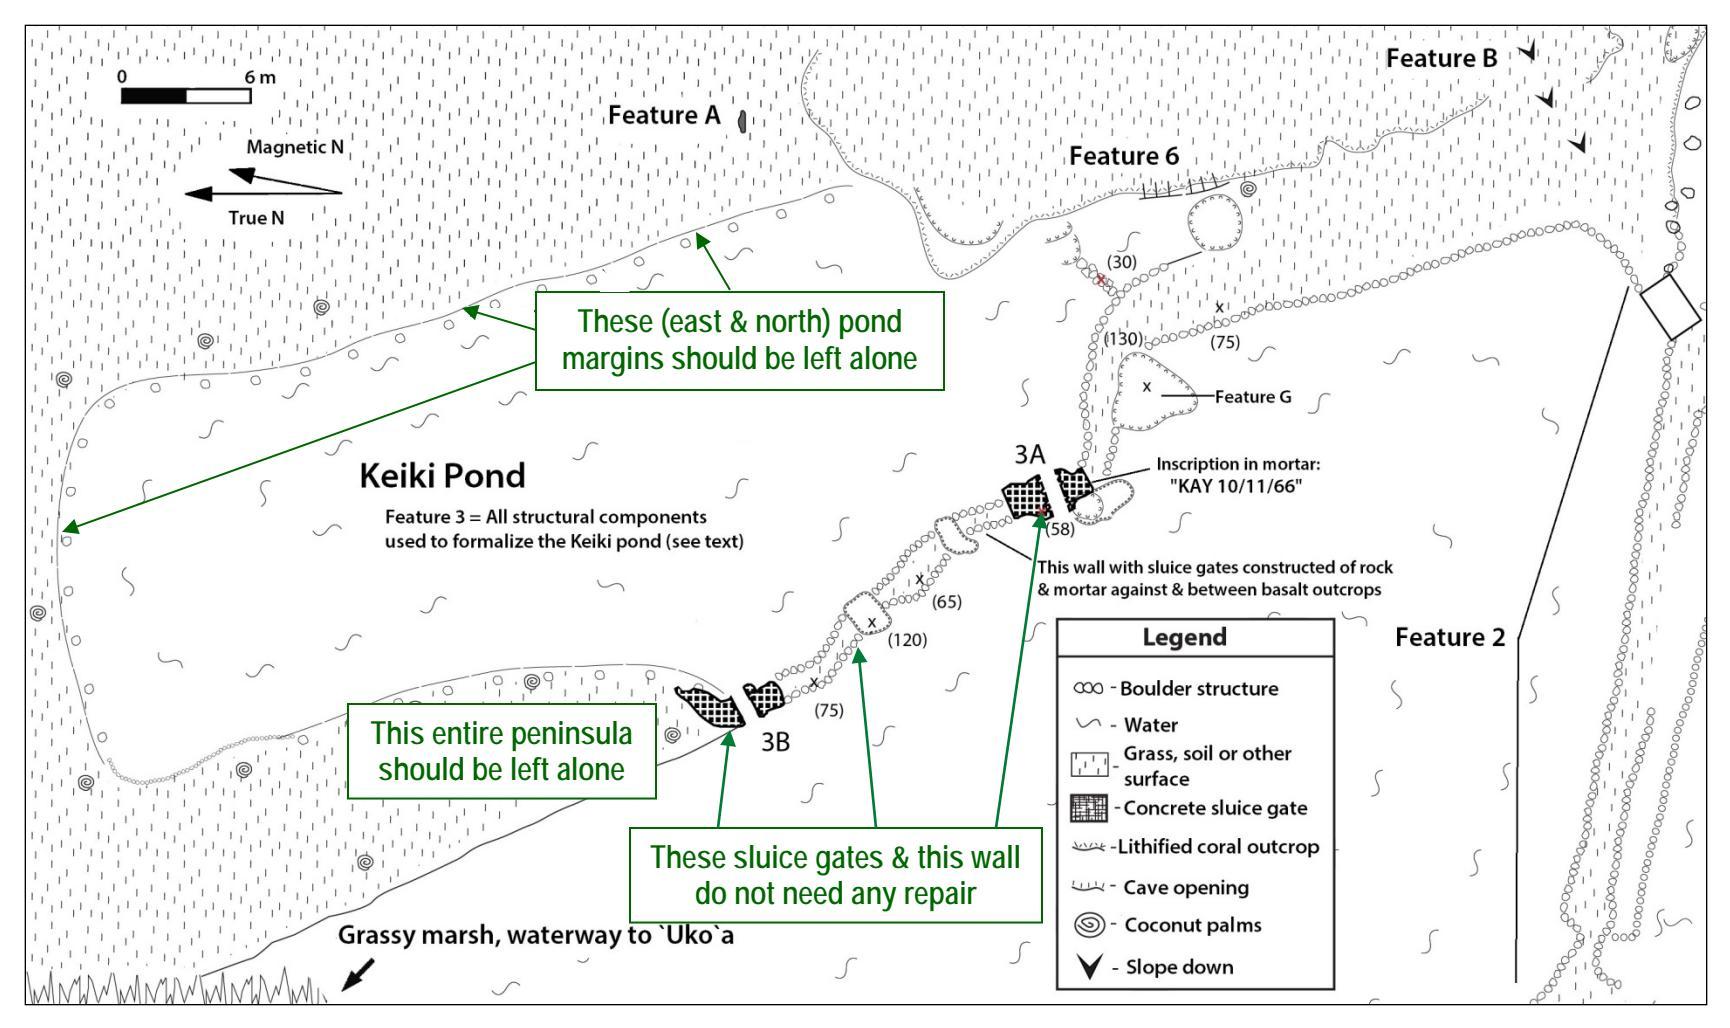
From a functional perspective, there is no reason to ever dismantle or remove the Keiki pond wall or the sluice gates, which function well (Figure 20). However, one long-term alteration that is not part of the Proposed Project, would not affect its functionality, but would improve its overall appearance, is to cover the sides of the existing walls with a dry-stacked pōhaku veneer that is visually consistent with the existing (circa 1930) Feature 2 rock work (Figure 21 and Figure 22).

Figure 20. Feature 3 plan view with preservation comments in green (see text for complete discussion)

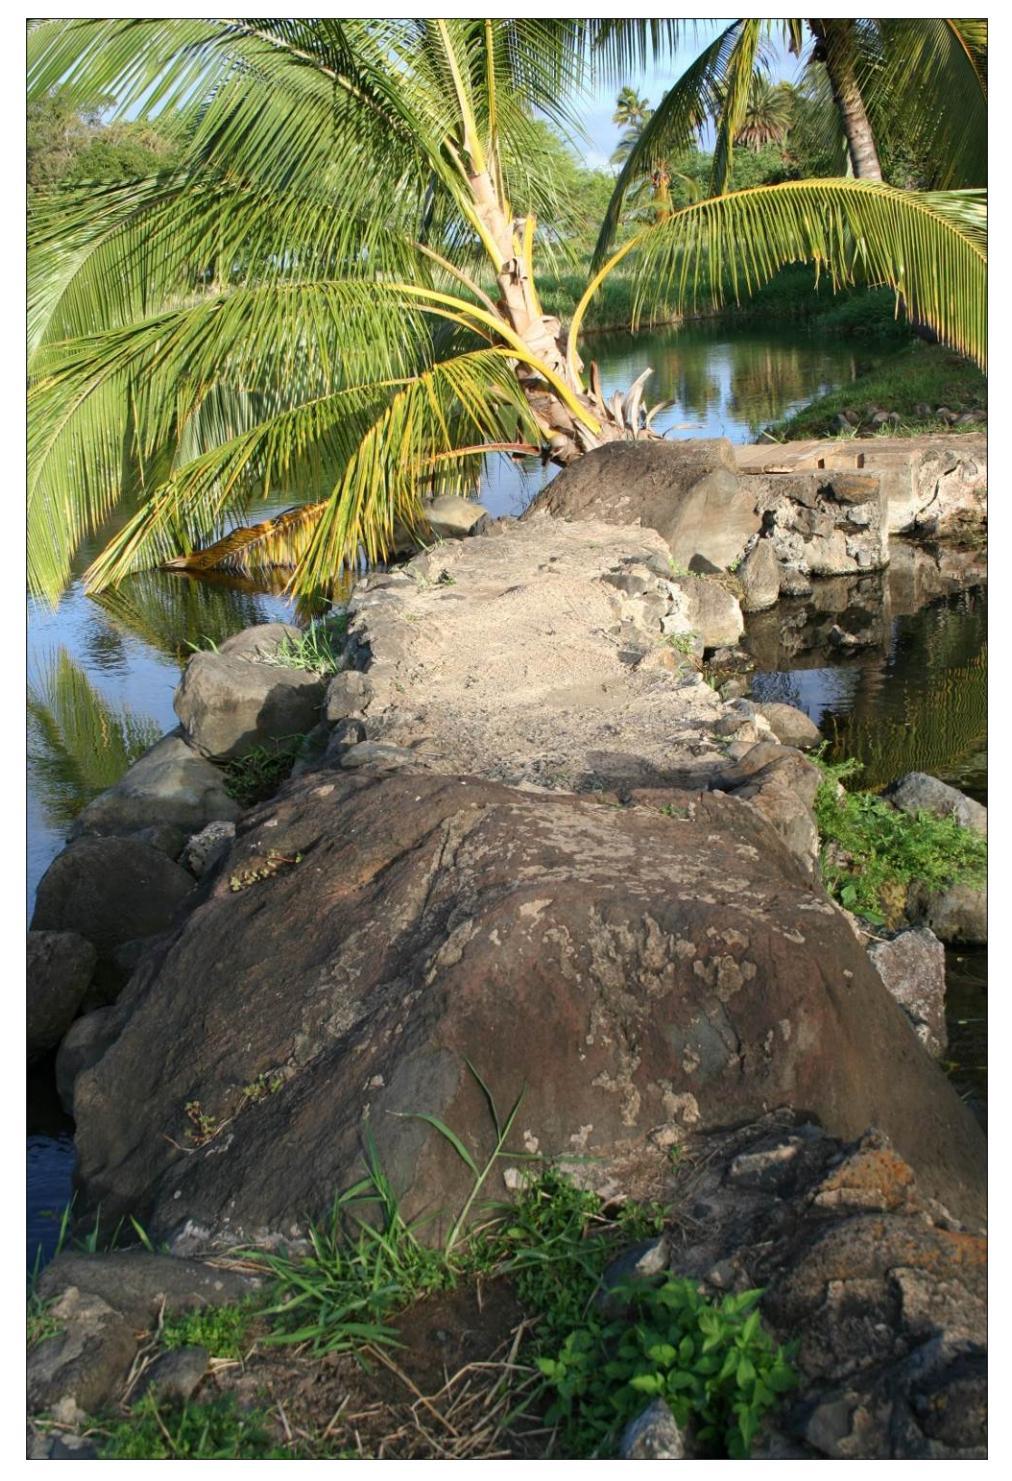
Figure 21. North portion of wall structure at Feature 3—which incorporates naturally-occurring basalt outcrops (foreground) connected by mortar-and-rock sections; view north-northwest

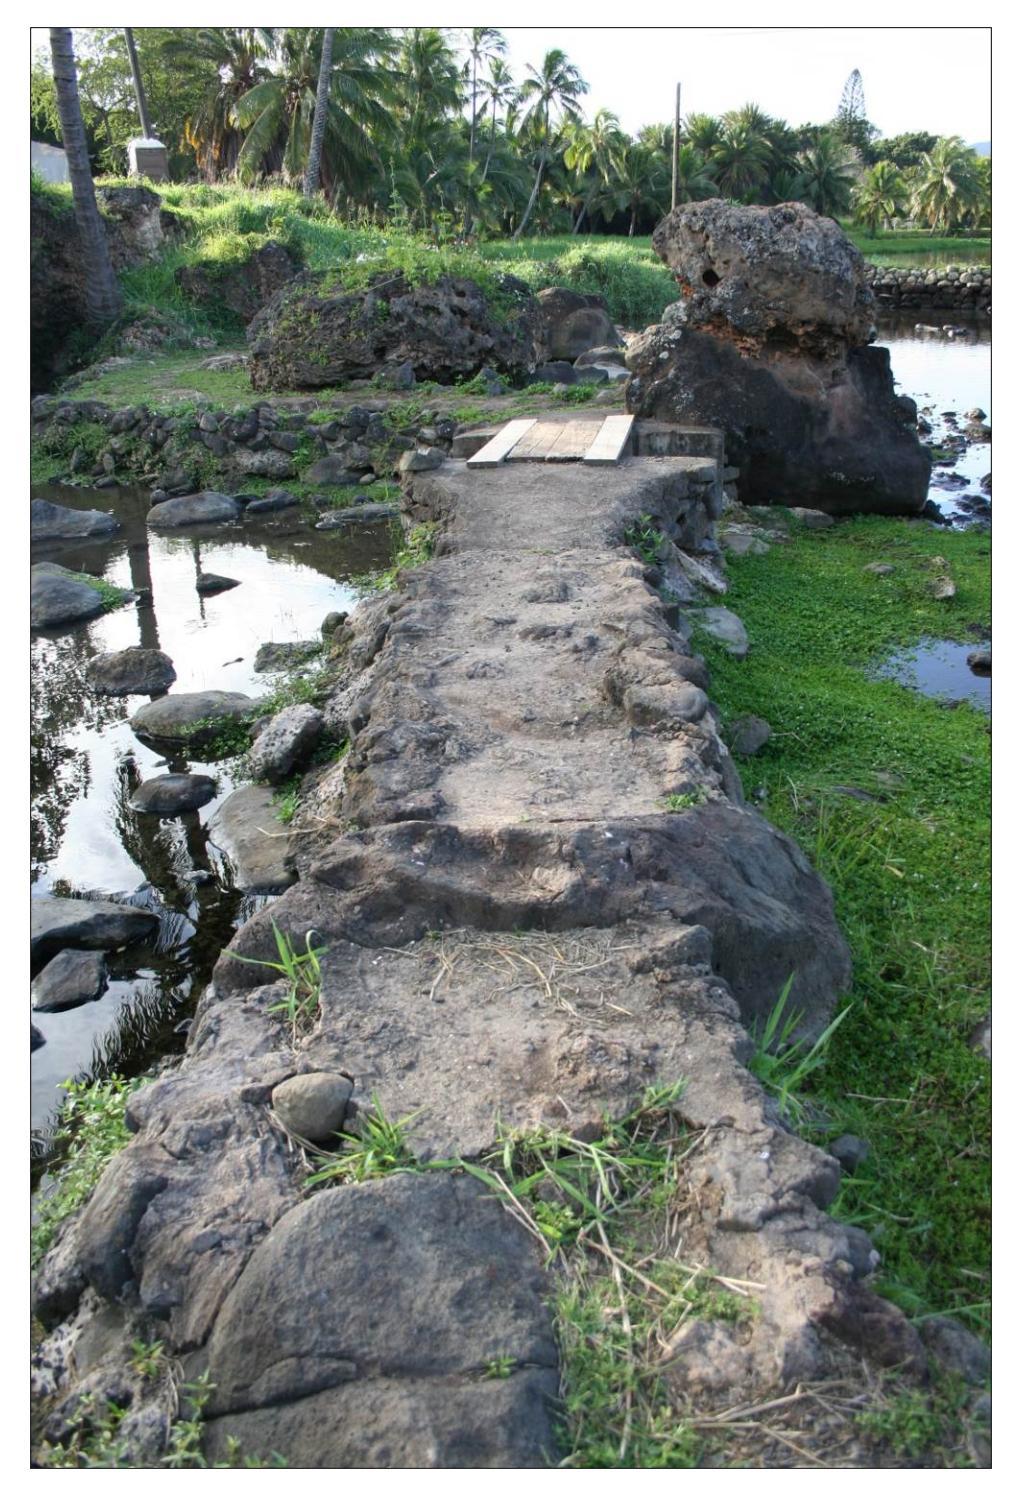
Figure 22. South portion of wall structure at Feature 3; view south-southeast

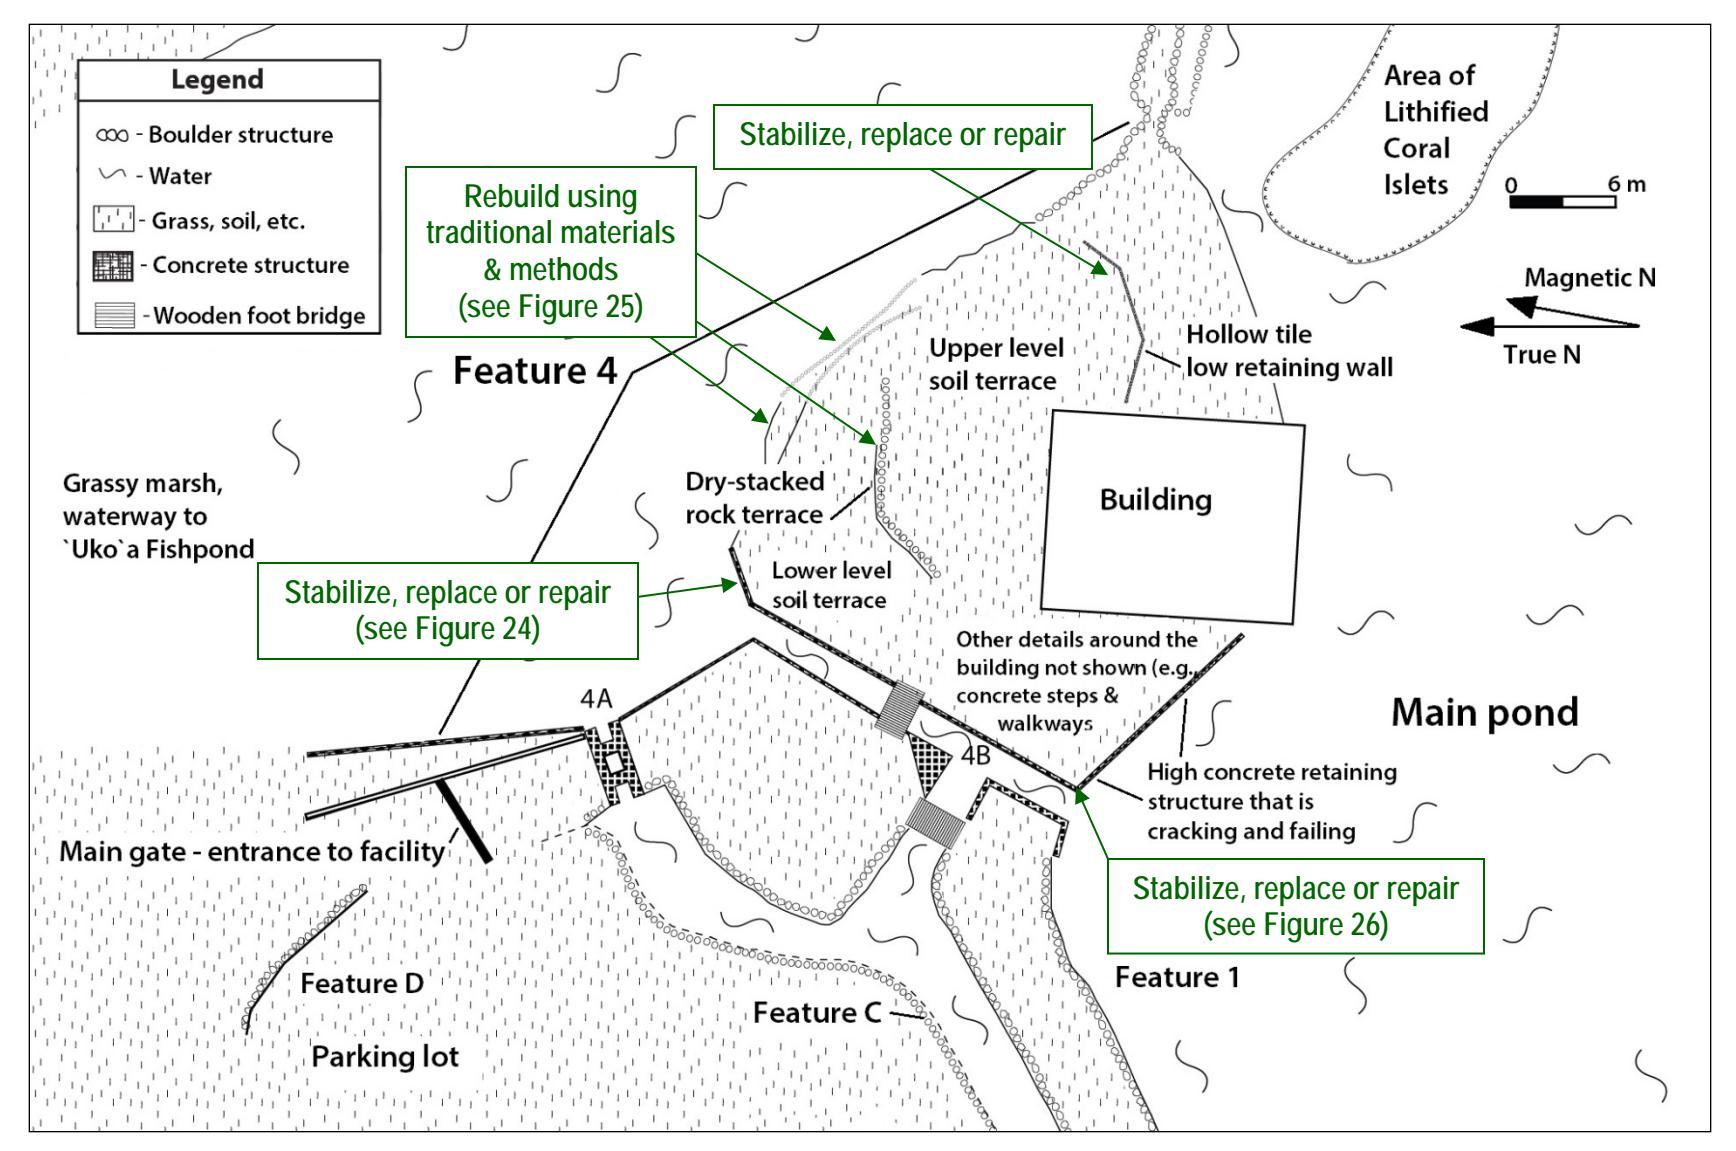
There is a set of dry-stacked, rock-retaining structures on the east and northeast sides of the central island. These informally-constructed features vary in terms of their physical condition from fair to poor, and their age is unknown. Their integrity has been diminished over time by the growth of a large hau thicket that until recently covered this area. When and if this rock work needs to be replaced, it would be aesthetically pleasing if it were finished in the dry-stacking style seen along the north side of Feature 2. Likewise, if repair work is ever needed of the dry-stacked, rock-retaining structure between the lower and upper terraces on the north side of the island (see Figure 25), it should be built in this Feature 2 style.

Figure 23. Feature 4 plan view with other recommended long-term alterations in green (see text for complete discussion)

Since they are currently functioning quite well, the various concrete and metal sluice gates and storage compartments/ holding tanks need not be altered or changed at this time. If they do need work in the future, they should be rehabilitated, restored and/or reconstructed in the 1930s style in order to maintain the "plantation era" feel of the central island.

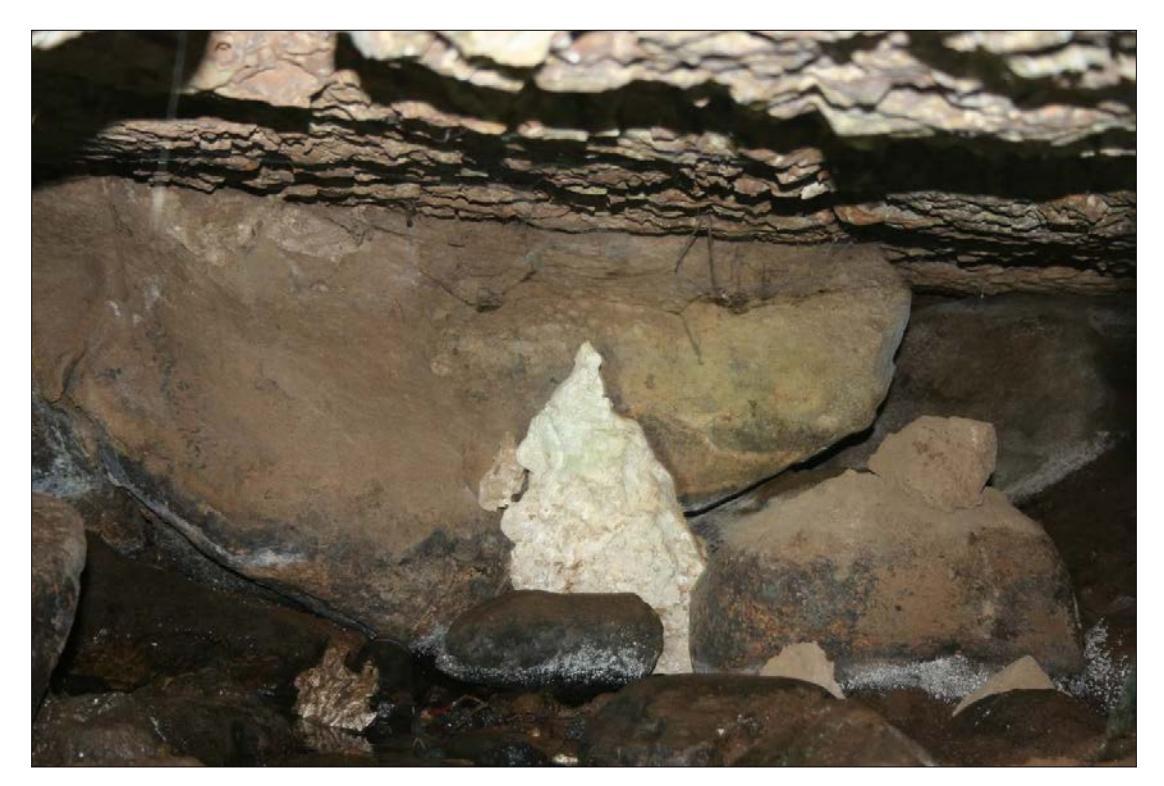
As documented in the AIS report, the north cave (Feature 6) contains a triangular upright slab of lithified coral several feet inside the drip line (Figure 27). We did not find any other items of possible cultural significance in either of the caves, but the presence of fresh water springs and association with the mo'o Laniwahine (some believe one or both caves may be her home) suggests some Native Hawaiians may wish to visit these quiet places for cultural or religious purposes. We recommend these caves be kept clean of rubbish in recognition of their special value.

Figure 27. White-colored upright coral slab within the north cave (Feature 6); the slab is about 40 cm high

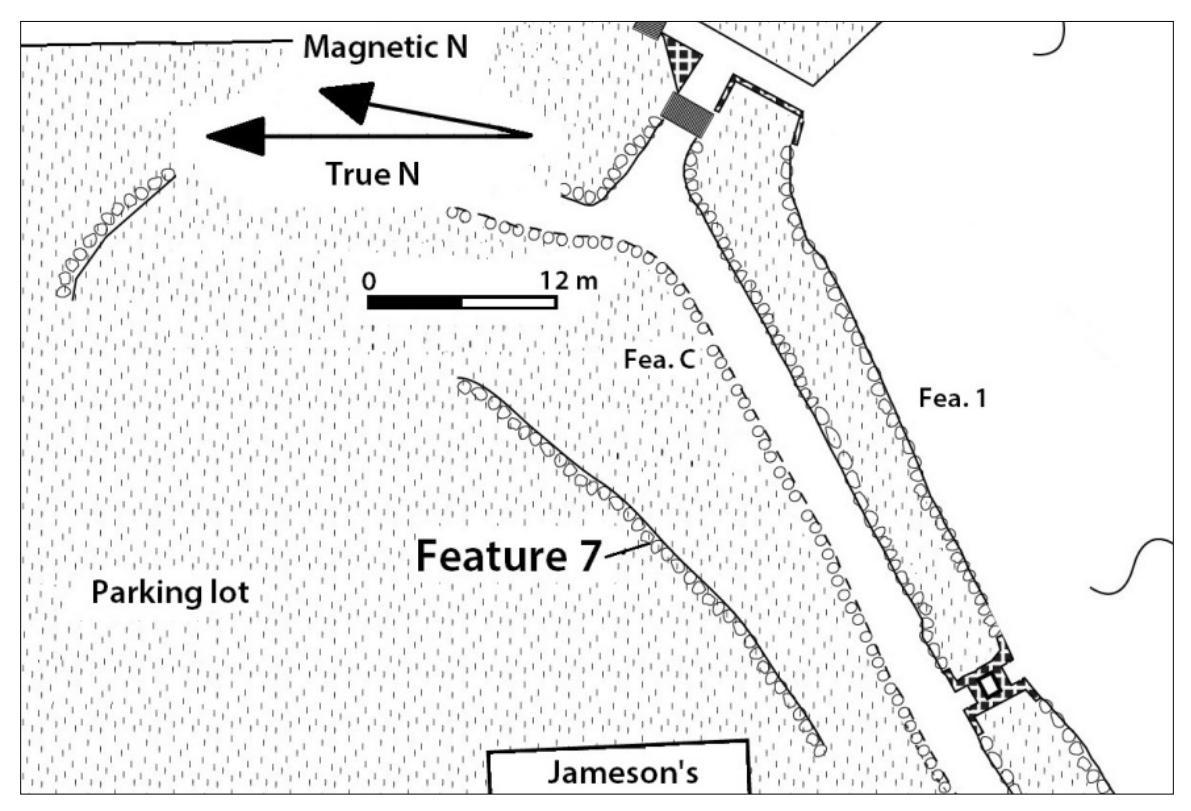
Figure 28. Plan view showing the location of Feature 7, dry-stacked boundary wall along the TMK boundary with 6-2-003:014; note the building (mauka edge of its footprint is shown at the bottom) is now Haleiwa Beach House restaurant (not Jameson's)

This low, dry-stacked rock wall along the property boundary with the old Jameson's (now Haleiwa Beach House) parcel should be avoided and protected from disturbance in perpetuity (Figure 28). The rock work suggests it was built in the 19th century and likely represents a boundary marker. It would be a good idea to work with the adjacent (Jameson's parcel) landowner to educate he/she about the wall's preservation status.

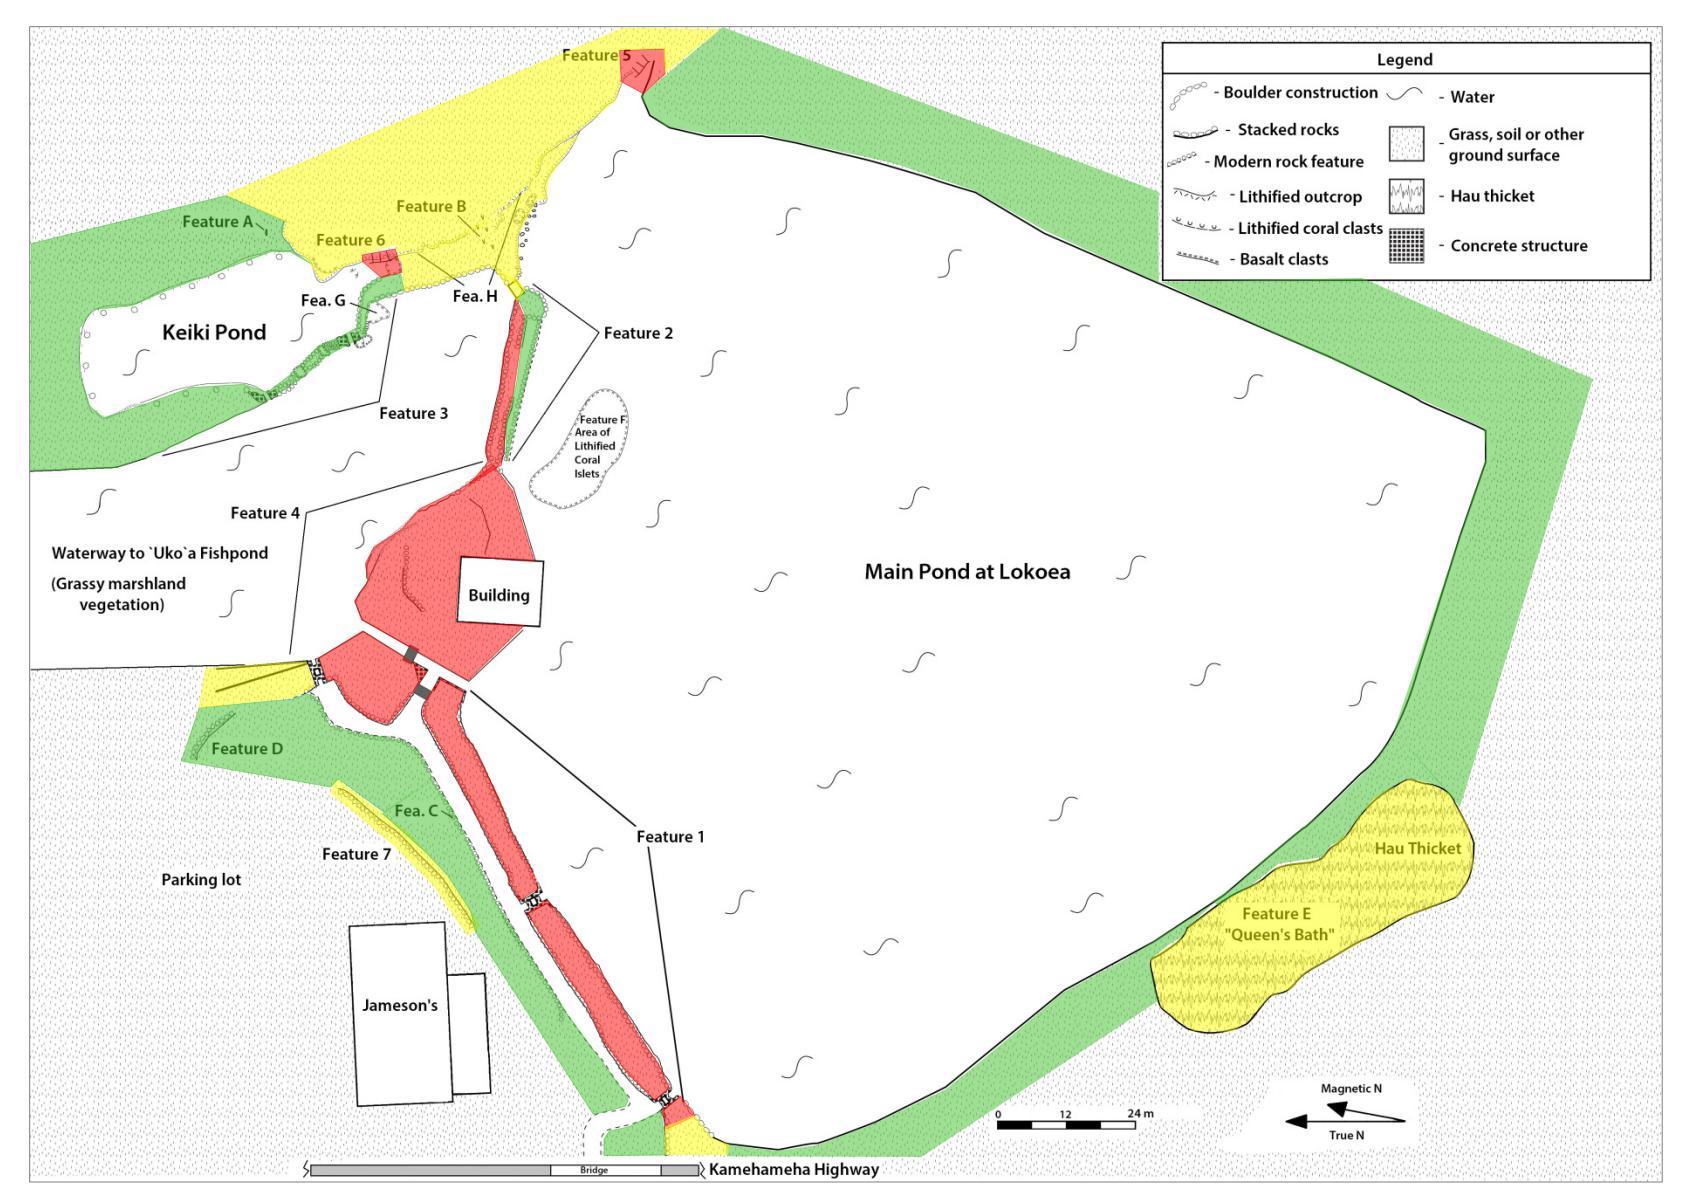
For example, replacement of the makai sluice gate (Feature 1), which is structurally unsound, will likely require the use of mechanical equipment. The AIS found evidence of an older, buried concrete gate immediately makai of the existing gate starting at about a foot below the ground surface. The rest of this structure, which either comes very close to, or rests right against, the existing gate, should be exposed by hand excavation and documented prior to removal of the failed sluice gate. Extending further makai (to the west), the AIS found mostly disturbance and fill from a 1980s rebuilding effort, but possible remnants of the very oldest (traditional-style) wall were exposed in deep excavation, just above the water table; therefore, this area is yellow in Figure 31 given its moderate potential for additional subsurface finds.

Figure 31. Plan view of Lokoea with color-coded depiction of low (green), moderate (yellow) and high (red) probability of encountering historicallysignificant subsurface deposits (see text for complete discussion); note, uncolored portions of the map have not been evaluated in this plan

Finally, mechanical excavation in the yellow areas (moderate possibility of encountering historicallysignificant subsurface materials or features) should be evaluated on a case-by-case basis since these occur between high (red) and low (green) areas; and since, with a single exception (makai of the makai gate at Feature 1), these areas have not been tested (excavated during AIS work).
